Lessons from the Longford Gas Explosion and Fire

R. B. Hutchison^a, D. M. Boulton^b, R. M. Pitblado^c & G. D. Kenny^d

On 25 September 1998, a vessel in the Esso Longford Gas Plant, Victoria, Australia, fractured releasing hydrocarbon vapours and liquid. A major fire followed. Two Esso employees were killed and eight others were injured. Supplies of natural gas to domestic and industrial users were halted for between 9-19 days. The State of Victoria, which is highly dependent on natural gas, suffered substantial disruption to the economy. The Government ordered a Royal Commission to investigate the causes of the incident. DNV acted as technical adviser and the authors of this paper were members of the Royal Commission technical investigation team.

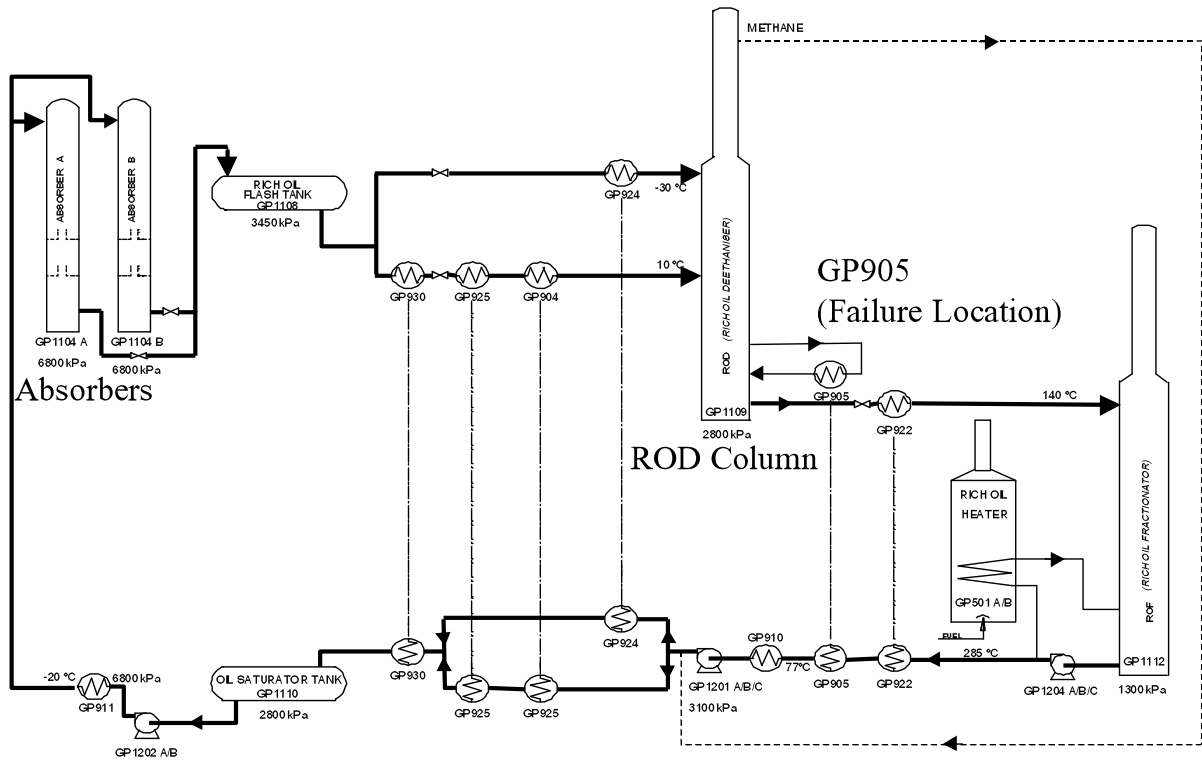
Figure 1 PFD for GP1's Absorber Oil Recirculation Loop

Rich Oil is passed, after flashing (Rich Oil Flash Tank) and heat exchange, to the ROD (Rich Oil De-ethaniser). This is a fractionation tower where methane is removed at the top and heavier components collect in the bottom and are recirculated by means of a reboiler, GP905, the item that failed in this accident.

The bottoms Rich Oil stream passes through another heat exchanger, GP922 (that was leaking on the day of the accident), to the ROF (Rich Oil Fractionator) where final fractionation of the Rich Oil occurs, regenerating the Lean Oil in the bottoms. This Lean Oil is passed to fired heaters and then through a series of other exchangers providing heat energy to the process, before returning to the Absorber in a closed loop.

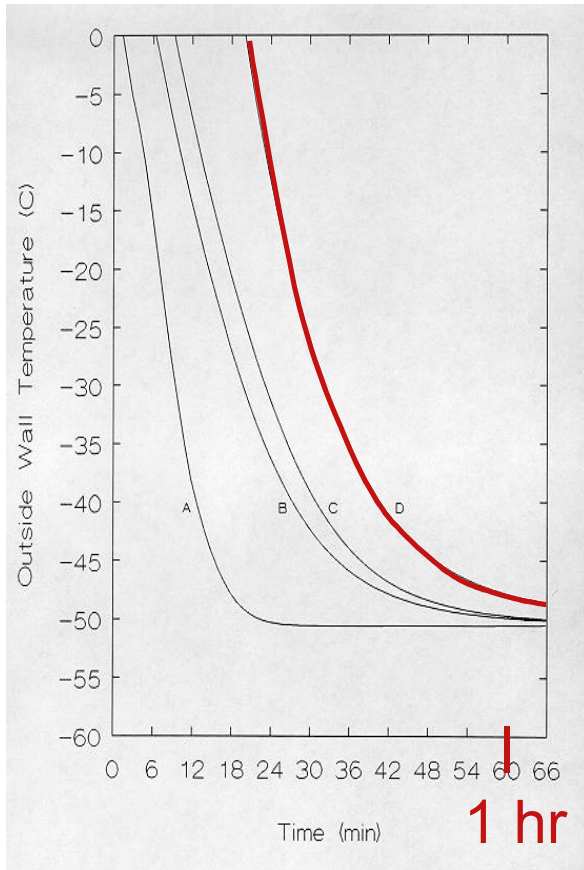
Figure 2 Simulation Results Graph

Following the cessation of lean oil flow, the condensate flowing from the absorbers through the rich oil system was flashing to lower and lower temperatures with the result that there was a drop in temperature in the Rich Oil Flash Tank and the ROD system.

Simulations indicate that the temperature reached as low as -48°C in this section of the plant.

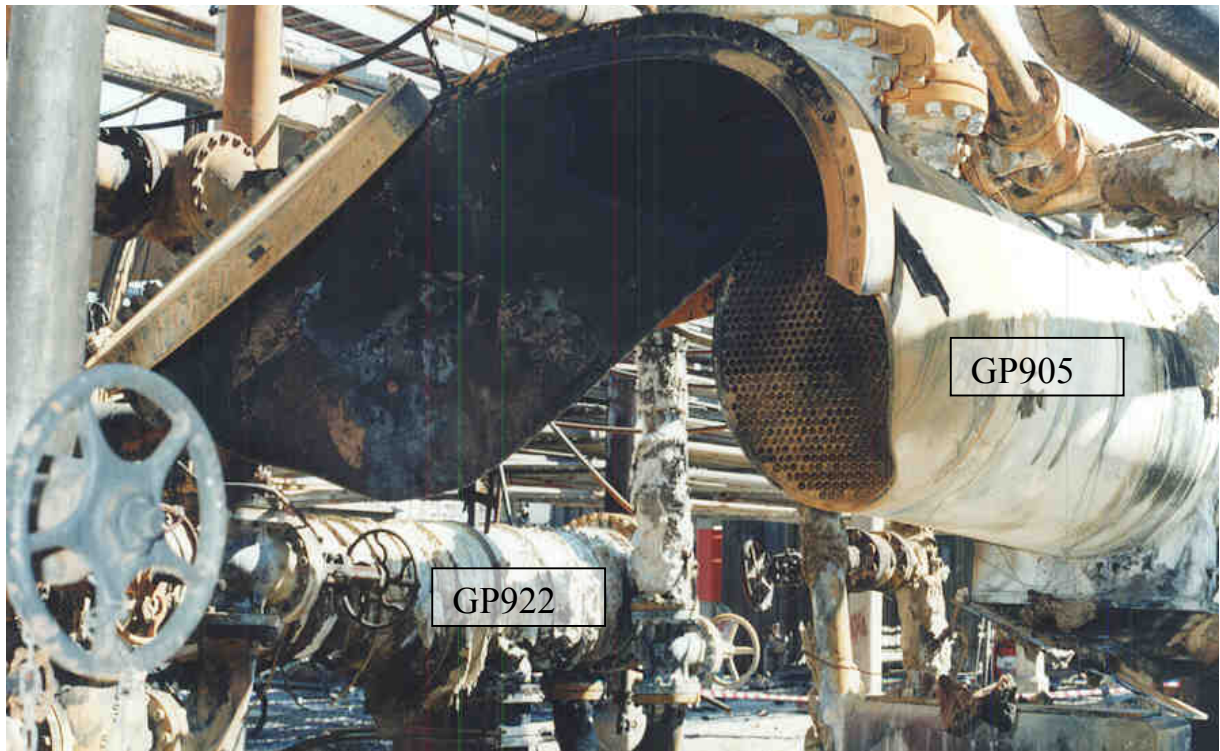
Figure 3 Failed End of GP905

One of the vessels involved was GP905. The reduction in temperature of that vessel caused the embrittlement of its steel shell. When hot lean oil was re-introduced into the vessel it ruptured by way of brittle fracture at its eastern end, releasing a volume of hydrocarbon vapour which travelled towards the area of the fired heaters where it ignited, causing an explosion and fire. (see Figure 3)

A catastrophic end failure occurred to exchanger GP905. Essentially the whole end was ripped open (see Figure 3) and the contents of the exchanger, the ROD

column, and all its interconnections were rapidly released. Metallurgical analysis showed... *The featured surface and ligaments indicate that the crack propagated slowly while it was in the weld. It is concluded that the failure in the channel was fast brittle fracture.*

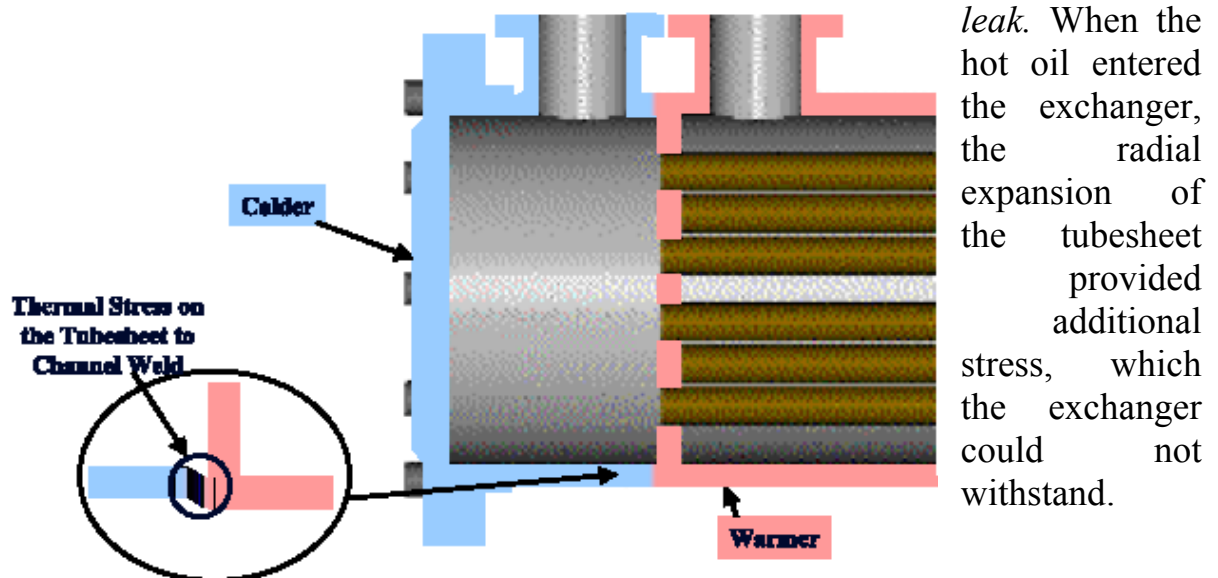
Figure 4 Thermal Stress Model

The exchanger, though not rated for the low temperature, did not fail due to the low temperature alone. Following leaks from a nearby exchanger (GP922) *the decision was made to re-introduce lean oil flow into GP922 to try and stop the leak.*

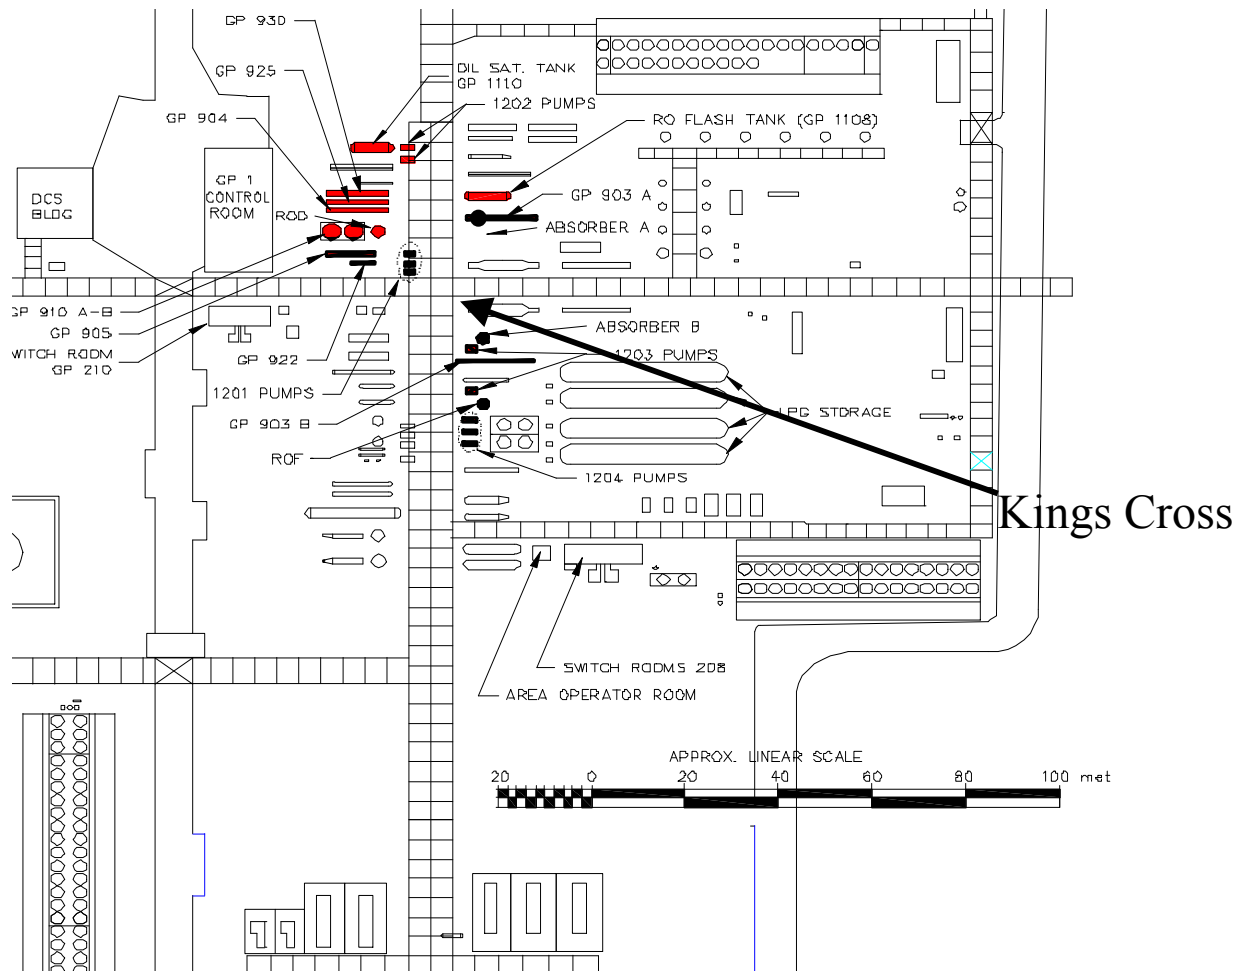
Figure 5 Plot Plan around GP905 and King's Cross Junction

A major problem for the Esso operating staff was to isolate the many pipes passing through this critical junction of pipe racks. The GP905 exchanger was 5 m to 10 m from this junction. The total isolation of the pipes feeding the fire required nearly 2½ days. This was due to major interconnections between the 3 gas plants. The Commission reported... *Geoff Evans, a [Country Fire Authority] operations manager, was concerned about the ad hoc nature of the isolation of fuel sources. At 2.30 pm on Saturday, 26 September, he had a discussion with Mick Brack, an Esso acting operations superintendent. He asked Brack for a detailed plan of the plant's pipework to assist the IMT (Incident Management Team) in identifying which valves should be isolated to stop the flow of fuel to the fires. Brack said that he did not have a plan available and that in any event, the Longford plant was a hybrid, having had its original design modified on a number of occasions, so that a plan, even if one could be located, might not have been of much assistance.*

Had the supply of flammable materials been isolated within minutes after GP905 ruptured, it is unlikely that any of the pipes in the piperacks would have failed as they did ... The availability of these further sources to fuel the fire completely changed the dimension and scale of the accident.
